## ATV Bearing with Pac Seal

### The Challenge:

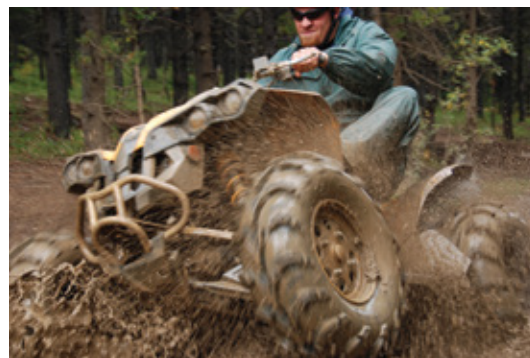
Current Supplier  
INBOARD GREASE - Water intrusion, grease discoloration and heavy corrosion

INBOARD RACEWAYS & BALLS - Heavy corrosion

INBOARD GREASE - Good condition

INBOARD RACEWAYS - Good condition

After analyzing the potential causes of the issue Koyo engineers recommended using a Koyo brand bearing with a pac seal to help prevent water and other contamination from coming into contact with the bearing.

Internal testing revealed the Koyo brand bearing with pac seal exhibited smooth rotation and excellent performance while the current supplier bearing exhibited rough rotation and endplay.
